Construction Report  
Experimental Features Project  
MEMBRANE PROTECTION FOR STEEL STRINGER TOPS

Yaquina Bay Bridge  
Newport, Oregon

Oregon Department of Transportation  
Highway Division

October 1980

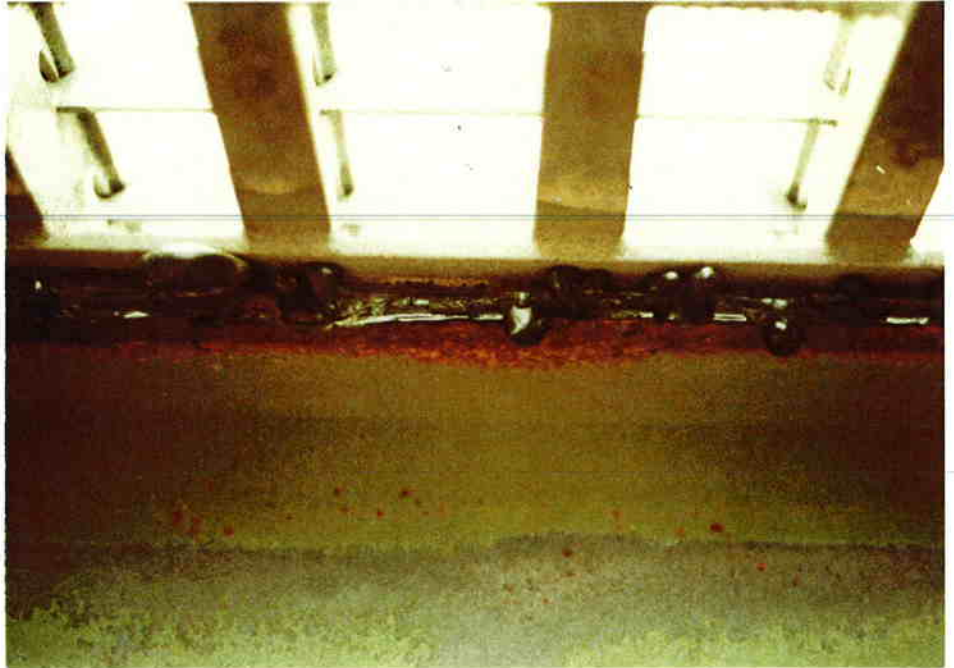
1-24-80

Squeezing out of Chevron  
Industrial Membrane in  
Span 2, due to improper  
mixture. Material did  
harden later.

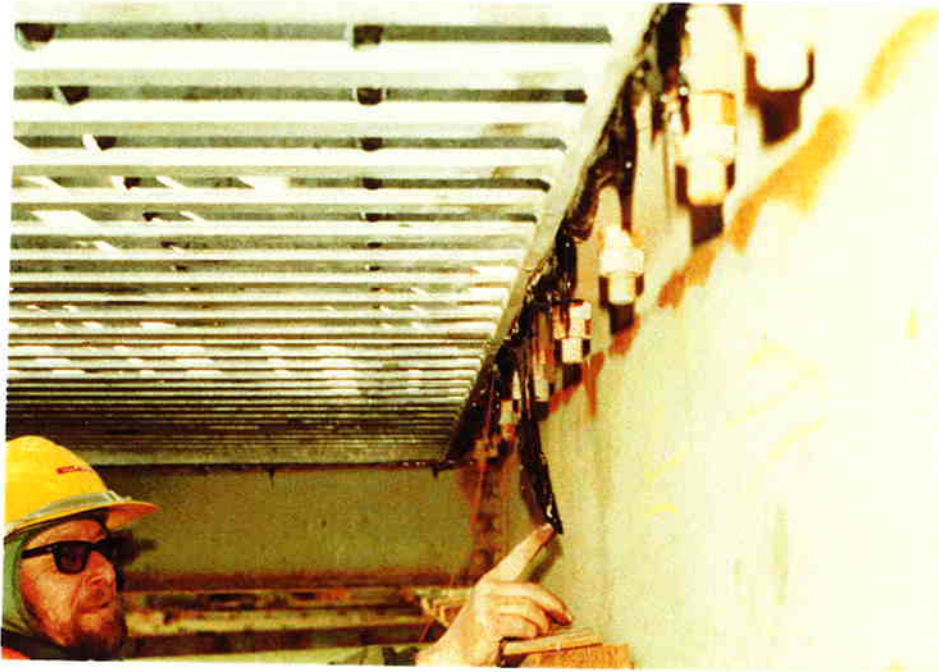
1-24-80

Looking at Chevron  
Industrial Membrane  
in Span 3 squeezing  
out after grid was  
laid and traffic  
allowed over top.  
Material did harden  
some time later,  
softness due to  
improper mixture.

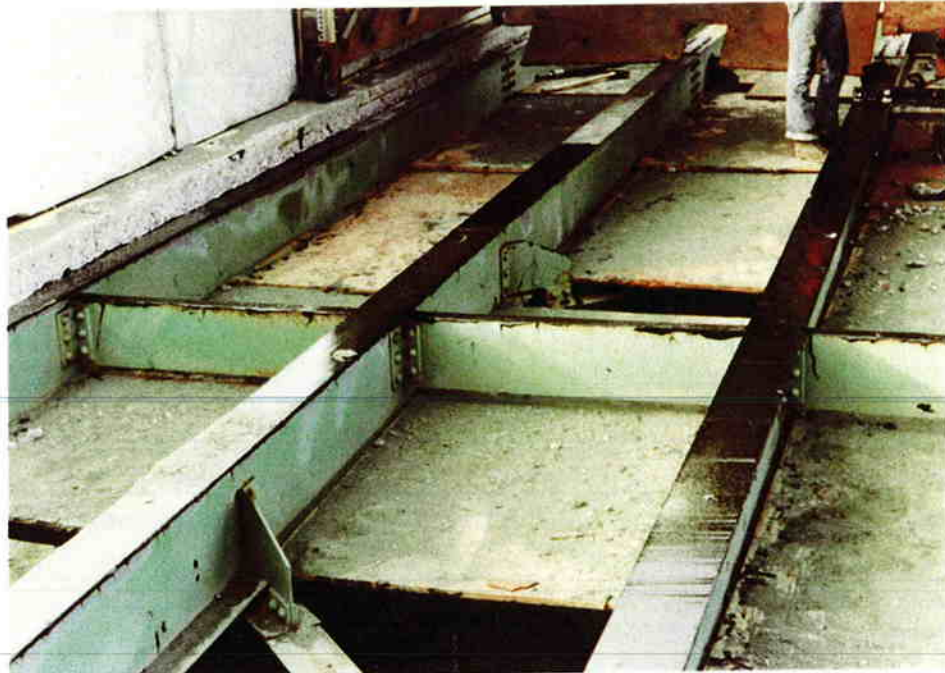
1-24-80

Looking at application of  
Chevron Industrial Membrane  
in Span 1.

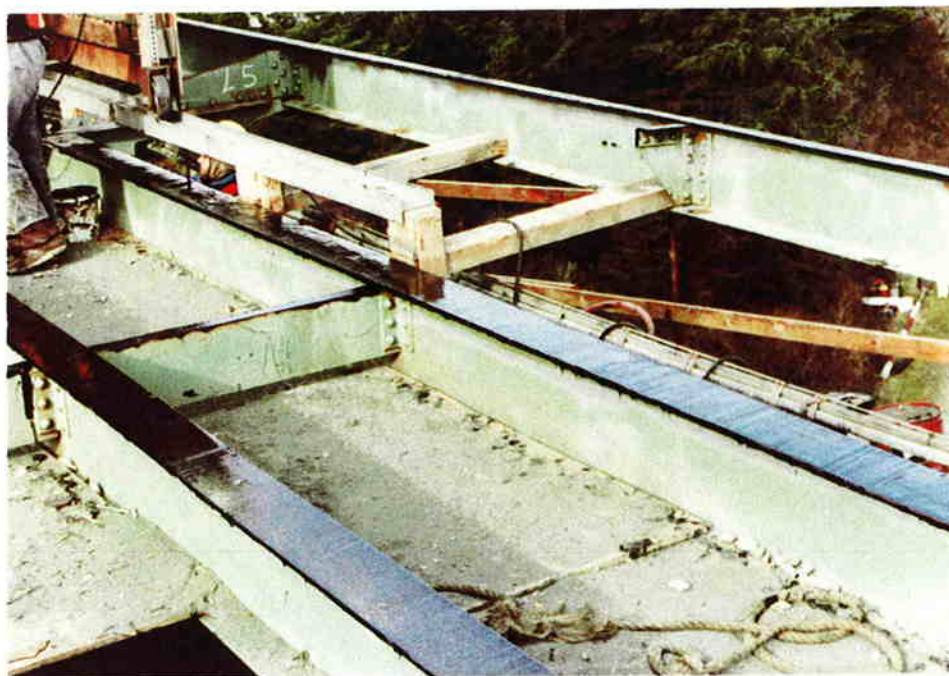
1-24-80

Looking at application  
of Chevron Industrial  
Membrane in Span 1.  
Note irregular surface  
of membrane.

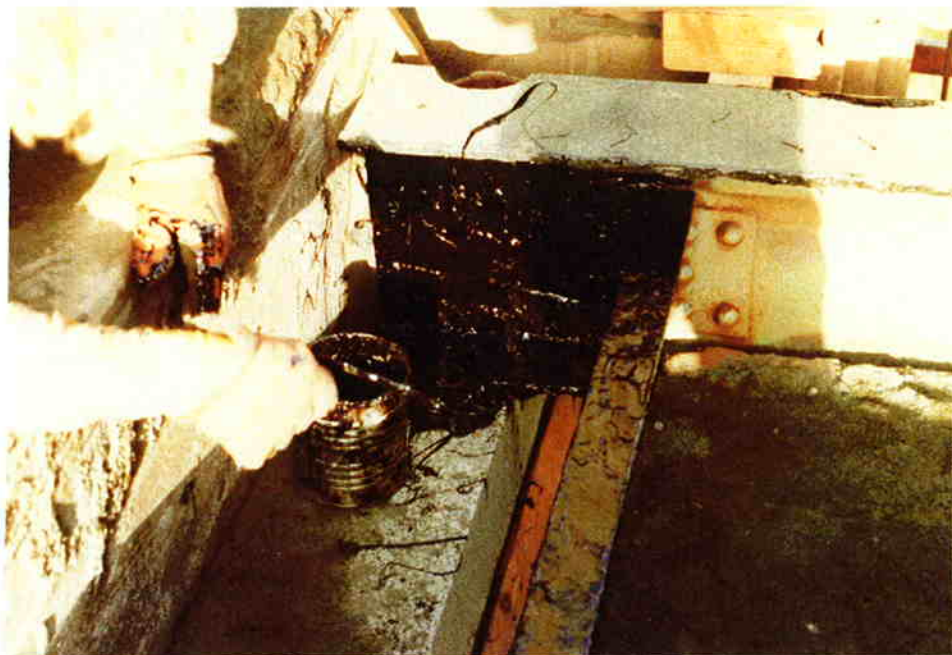
2-6-80

Application of Chevron  
Industrial Membrane on  
stringer beams at Pier 1.

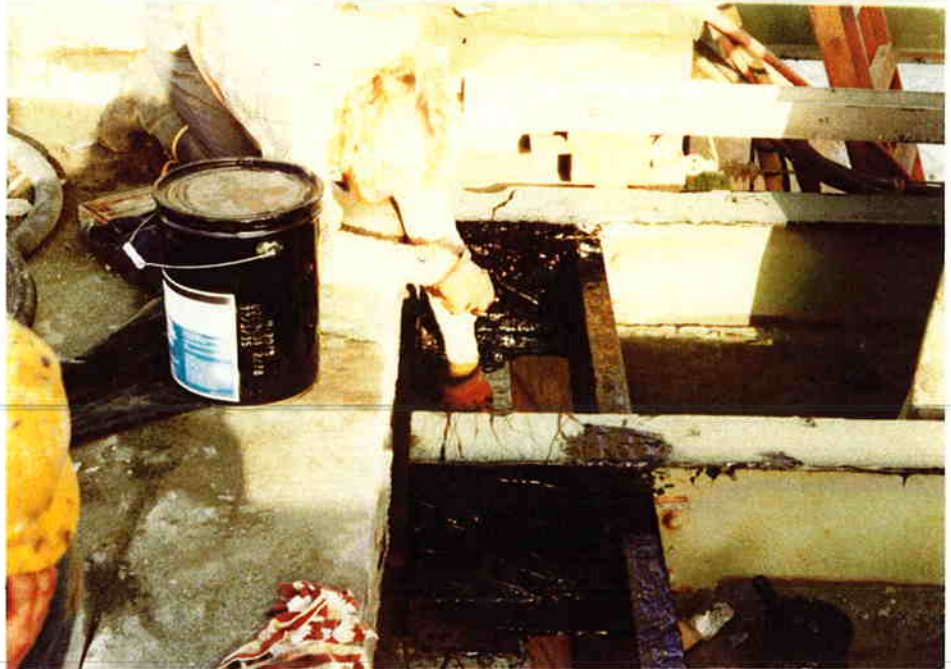
2-6-80

Coating beams at Pier 1  
after they were sandblasted.

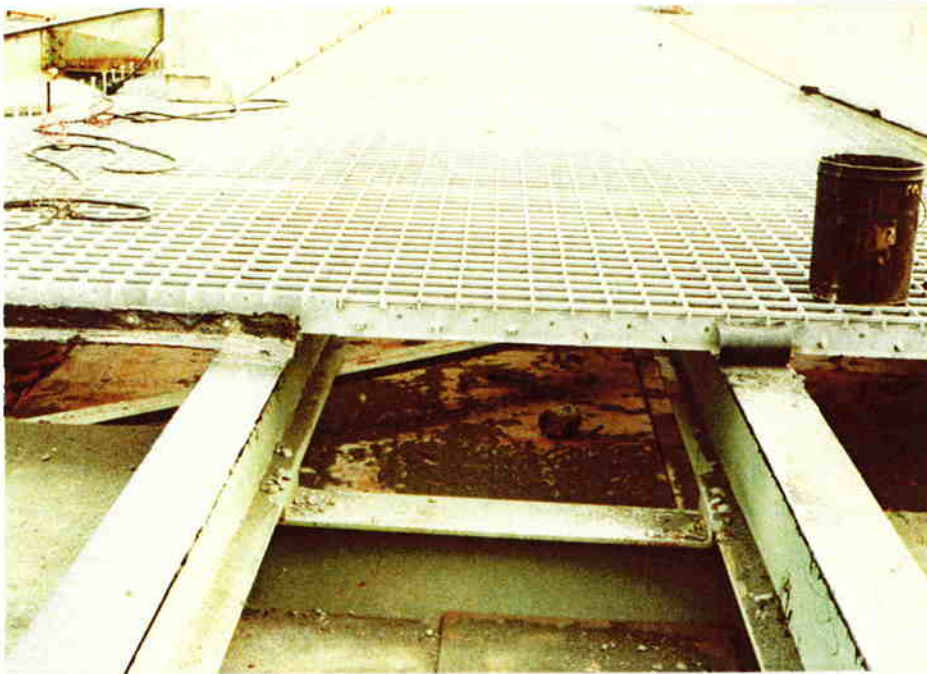
1-24-80

Looking at placement  
of grid panels.

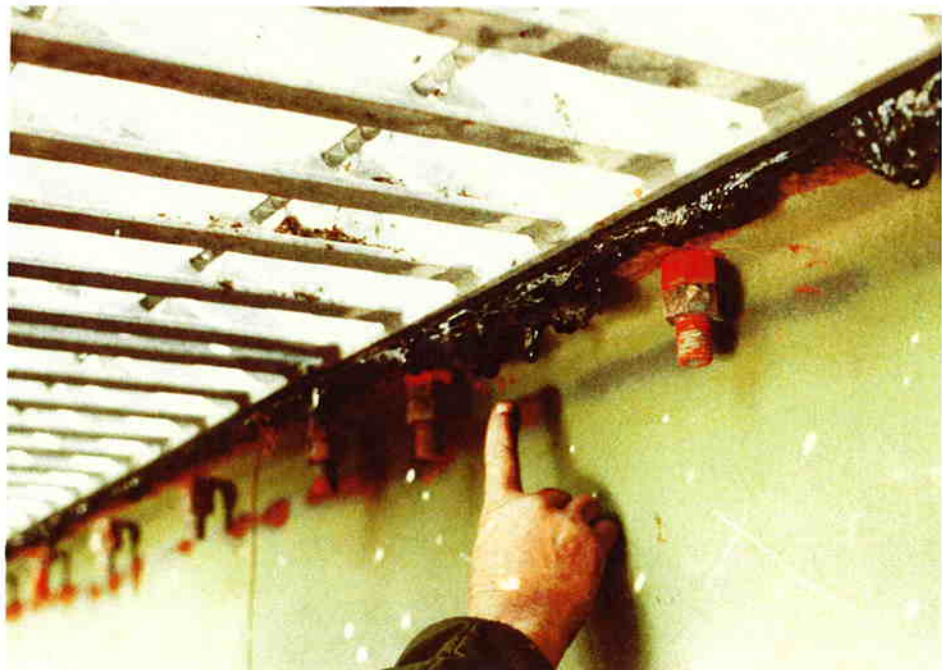
1-24-80

Chevron Industrial Membrane  
still soft and tacky after  
grid decking placement,  
probably due to improper  
mixture. Material did  
harden later.
